**PROPERTY CONDITION ASSESSMENT  
OF  
WORLD TRADE CENTER PORTFOLIO**

**SUBGRADE**

**FINAL DRAFT**

**Re: Due Diligence Physical Condition Survey**  
**World Trade Center**  
**New York, New York**

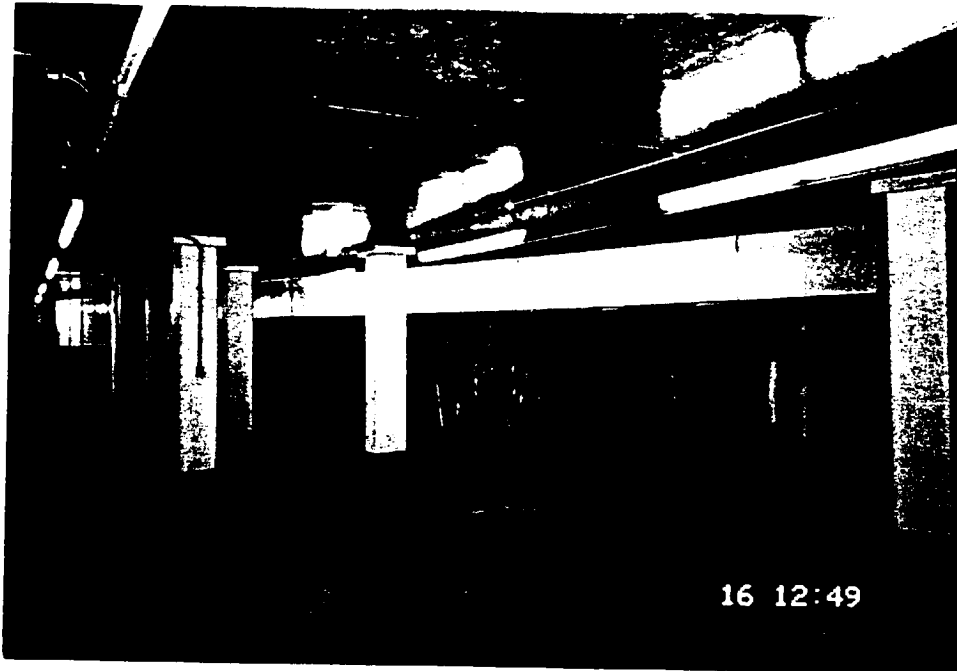
Photograph 1

Slurry wall exposed  
in Level B5

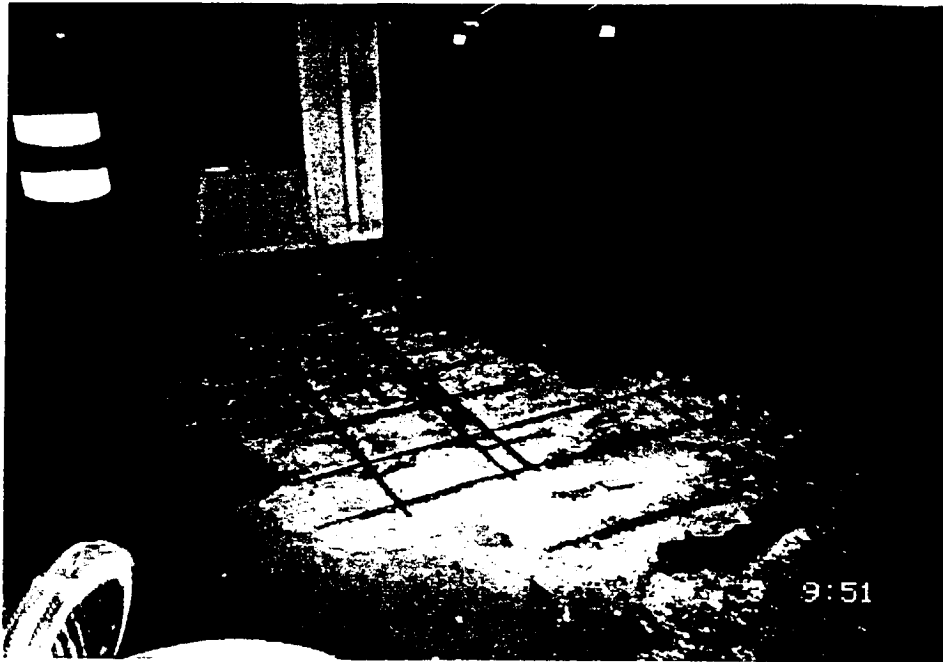
Photograph 7

Spalling garage  
slab - Level 2, North

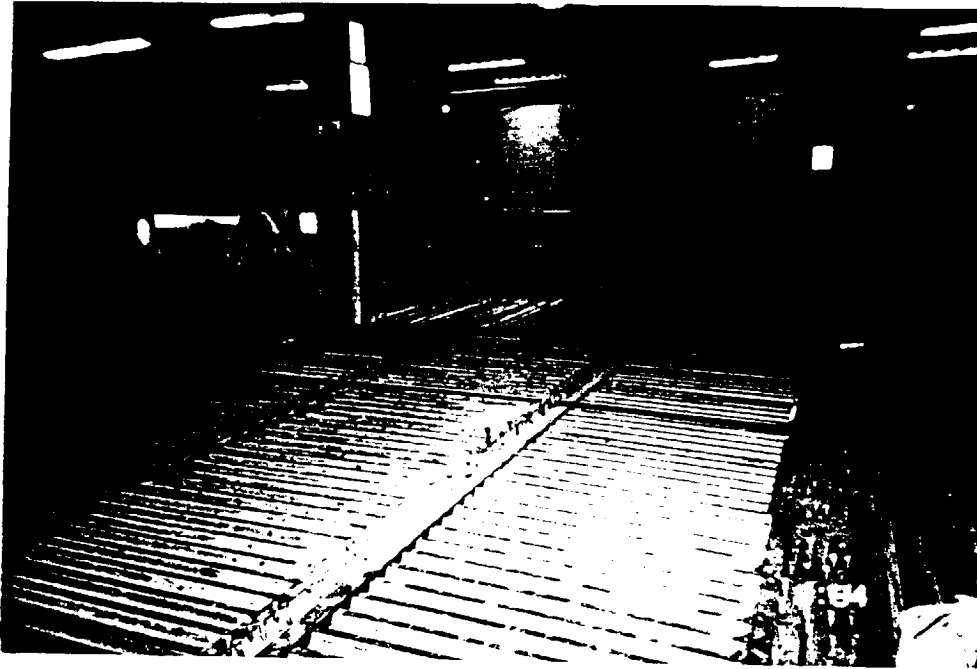
Photograph 9

New slab being  
installed in loading  
dock area - start of  
multi-stage program

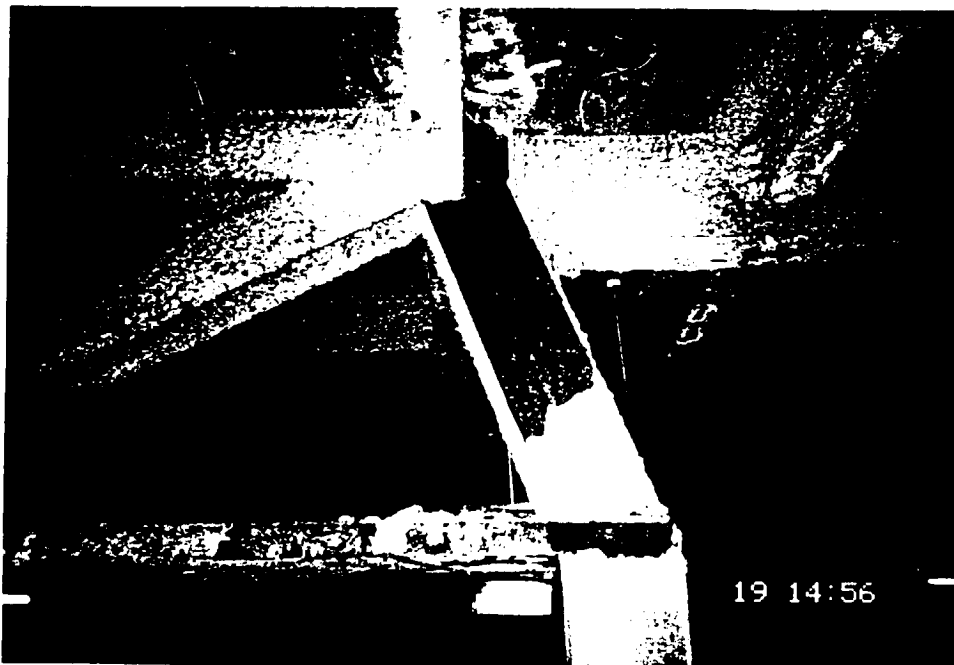
Photograph 14

Missing fireproofing  
at B-2 Garage

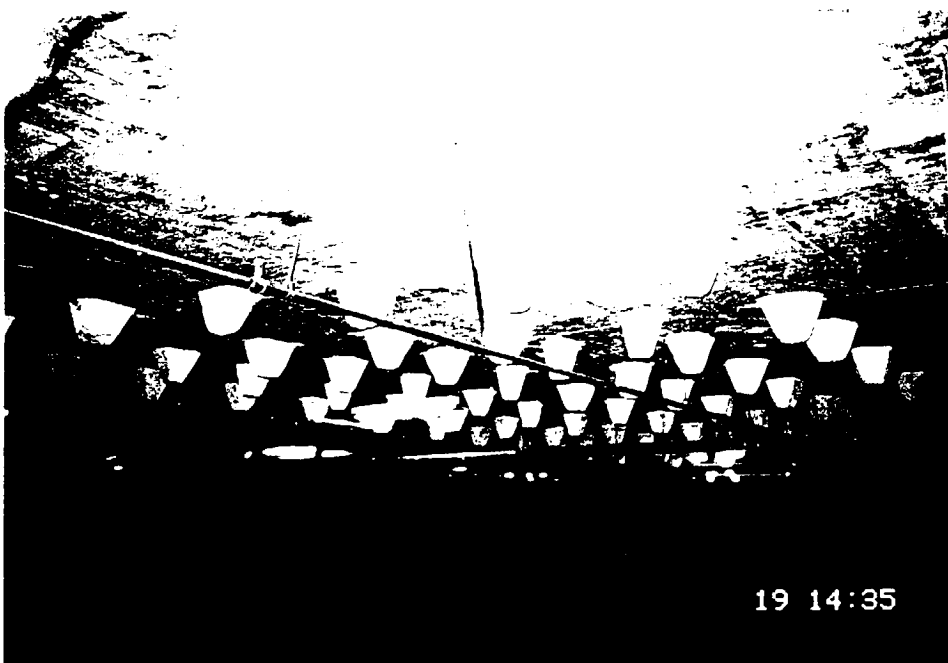
Photograph 16

Repairs of ceiling  
slab at B2 ceiling  
due to bomb  
explosion

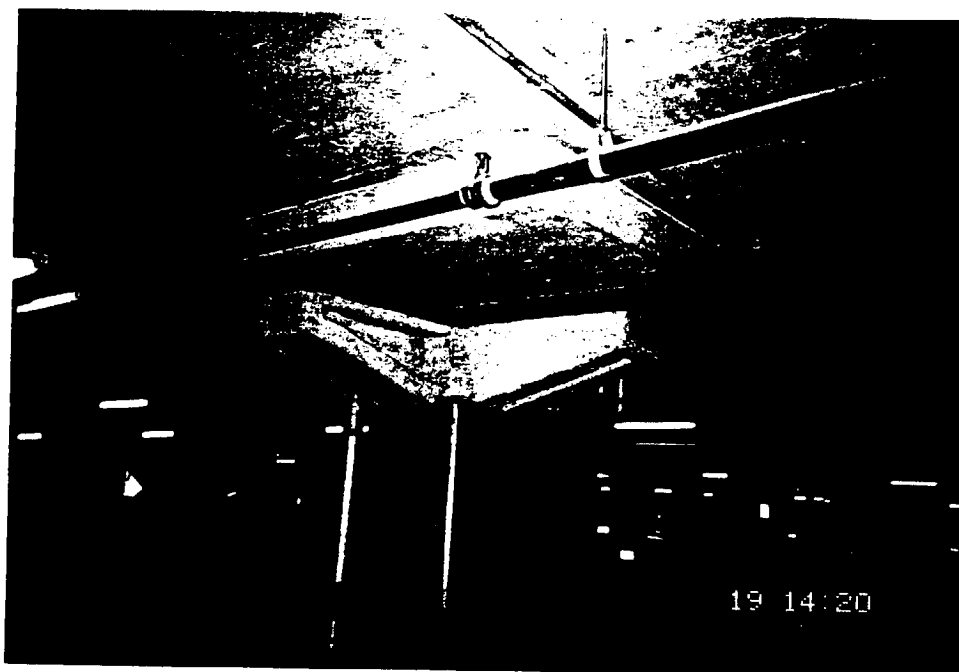
Photograph 17

Repairs at column  
brackets to support  
weakened slabs

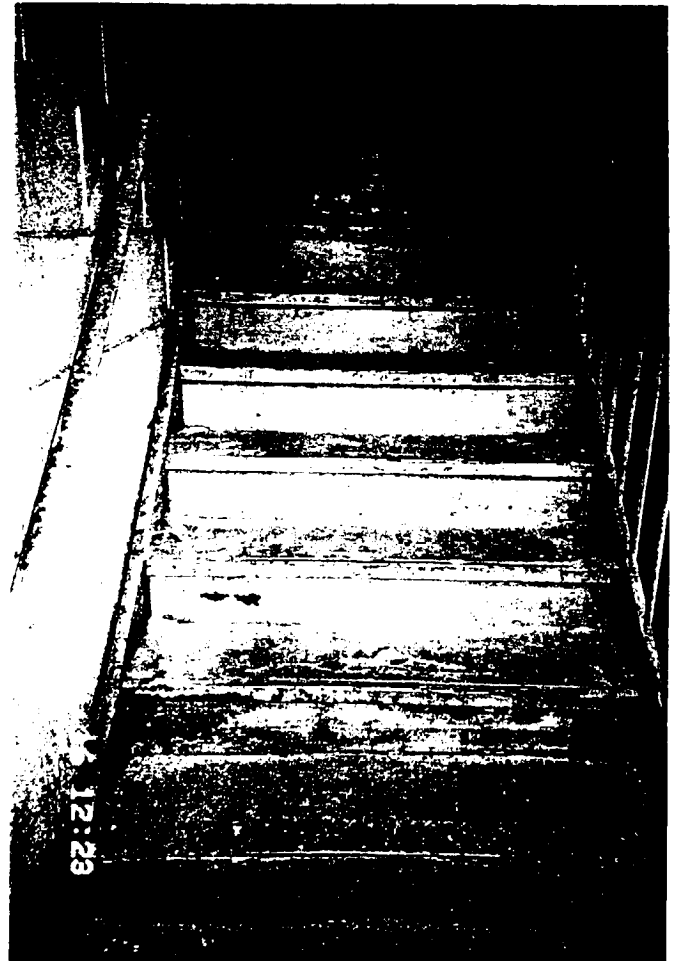
Photograph 22

Typical subgrade  
stair requires  
cleaning and  
some require  
painting

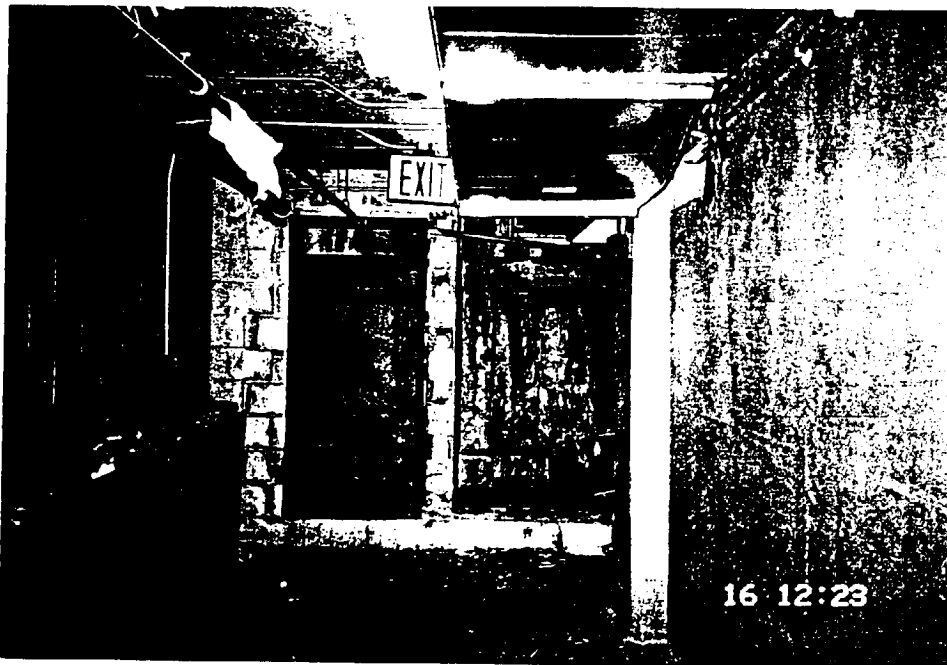
Photograph 24

B4 northeast stair  
door being replaced
