**PROPERTY CONDITION ASSESSMENT  
OF  
WORLD TRADE CENTER PORTFOLIO**

**SUBGRADE**

**FINAL DRAFT**

**Re: Due Diligence Physical Condition Survey**  
**World Trade Center**  
**New York, New York**

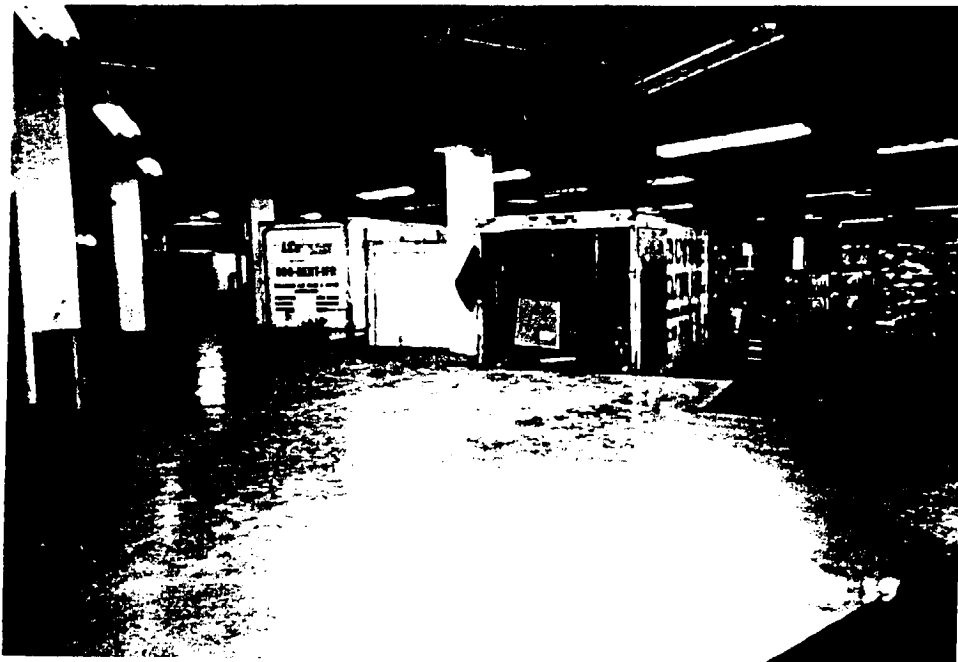
Photograph 10

Loading dock area

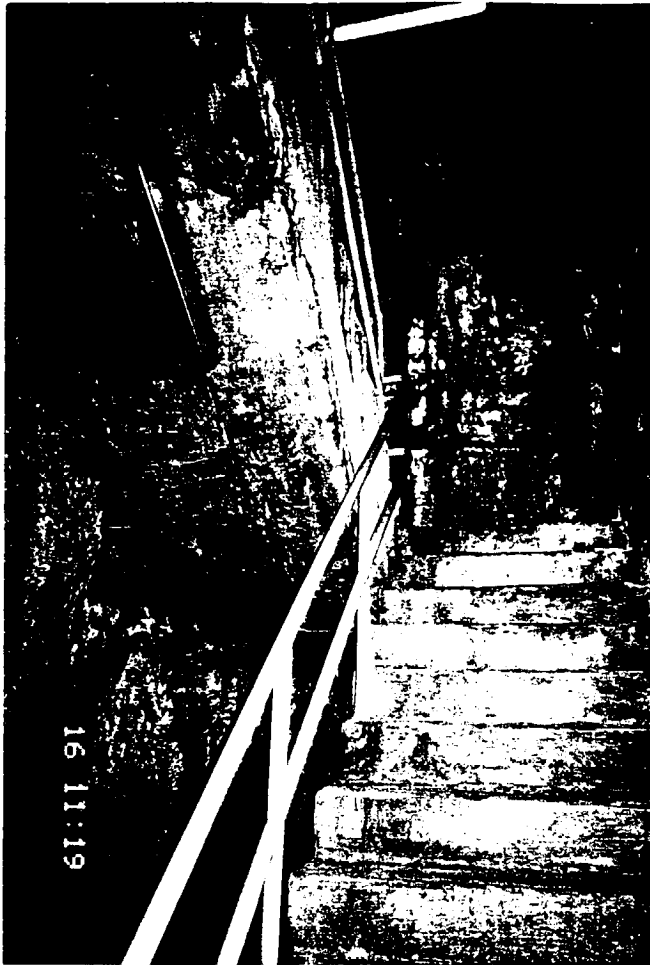
Photograph 21

Stair in projection  
serves as PATH  
emergency exit

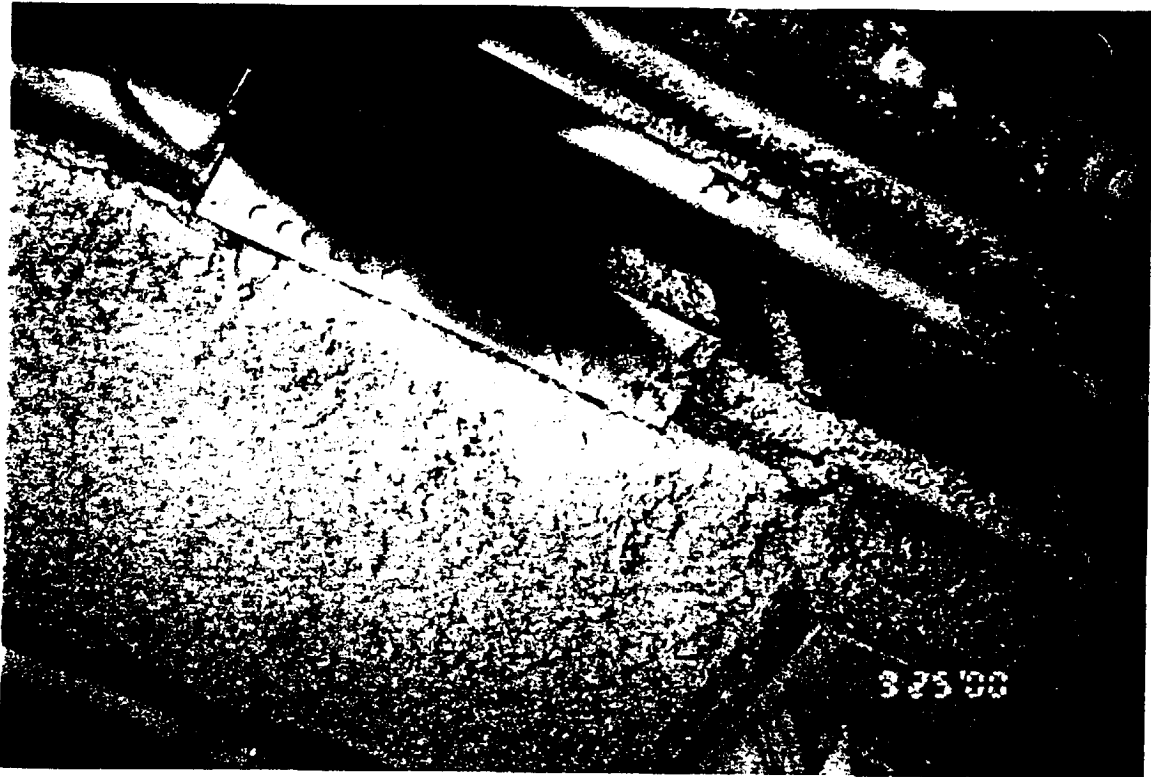
Photo #1: Spray-on fireproofing, loading dock area.
